# Uniform Mitigation Verification Inspection Form

Inspection Date: <b>1/5/2013</b>			
<b>Owner Information</b>			
Owner Name: <b>Sinha</b>		Contact Person:	
Address: <b>11801 NW 57th St</b>		Home Phone:	
City: <b>Coral Springs, FL</b>	Zip: <b>33076</b>	Work Phone:	
County: <b>Broward</b>		Cell Phone:	
Insurance Company:		Policy #:	
Year of Home: <b>2000</b>	# of Stories: <b>1</b>	Email:

### Supplemental Photo Pages

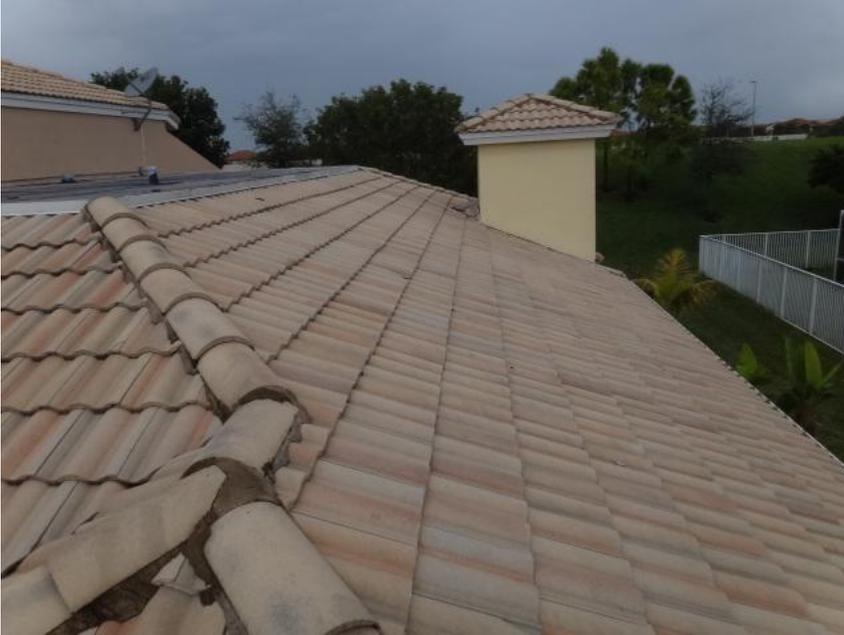
#### 2.1.2 Tile Roof

Permit Application Date	FBC or MDC Product Approval #	Year of Original Installation or Replacement	No Information Provided for Compliance
<input type="checkbox"/> 1. Asphalt/Fiberglass Shingle	-----	-----	---	<input type="checkbox"/>
<input checked="" type="checkbox"/> 2. Concrete/Clay Tile	6-9-1999	-----	2000.	<input type="checkbox"/>
<input type="checkbox"/> 3. Metal	-----	-----	---	<input type="checkbox"/>
<input checked="" type="checkbox"/> 4. Built Up	6-9-1999	-----	2000.	<input type="checkbox"/>
<input type="checkbox"/> 5. Membrane	-----	-----	---	<input type="checkbox"/>
<input type="checkbox"/> 6. Other	-----	-----	---	<input type="checkbox"/>

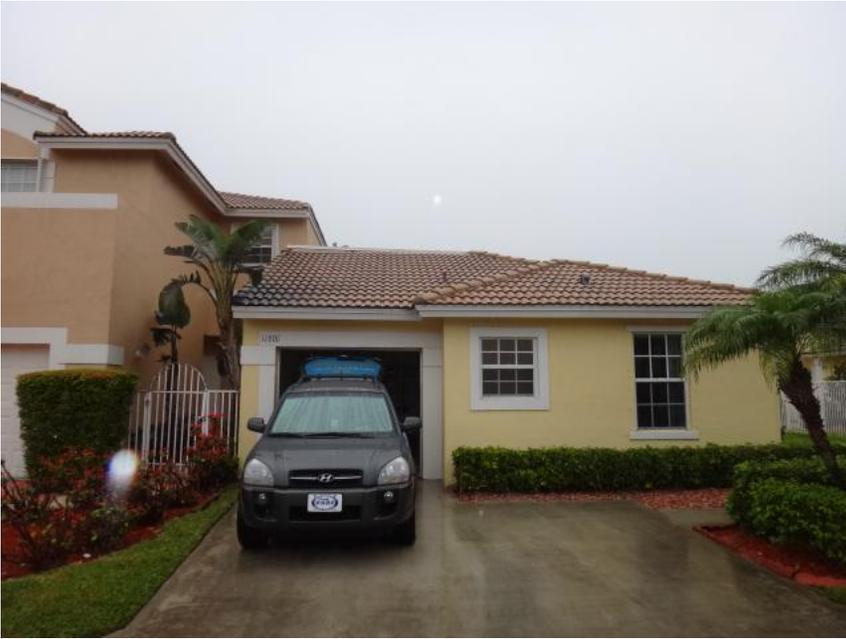
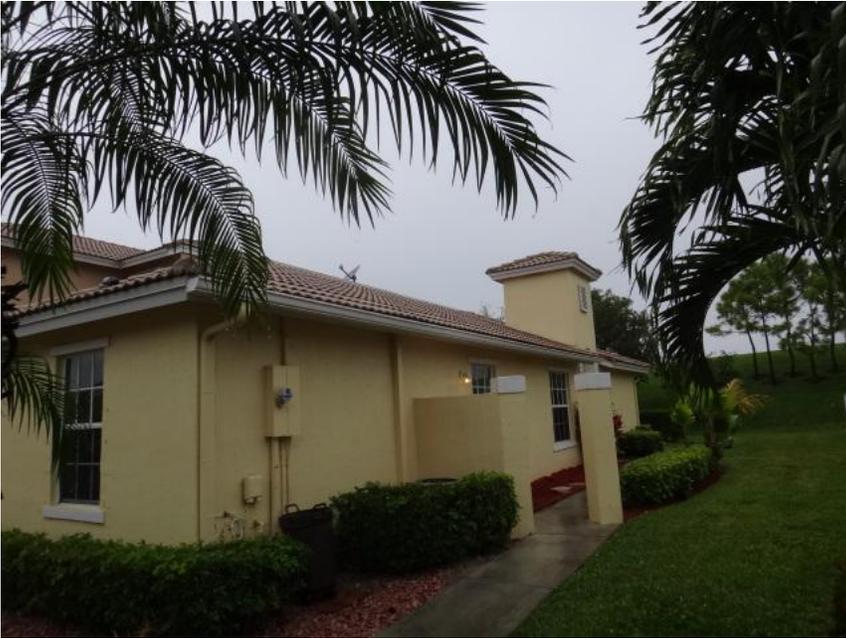
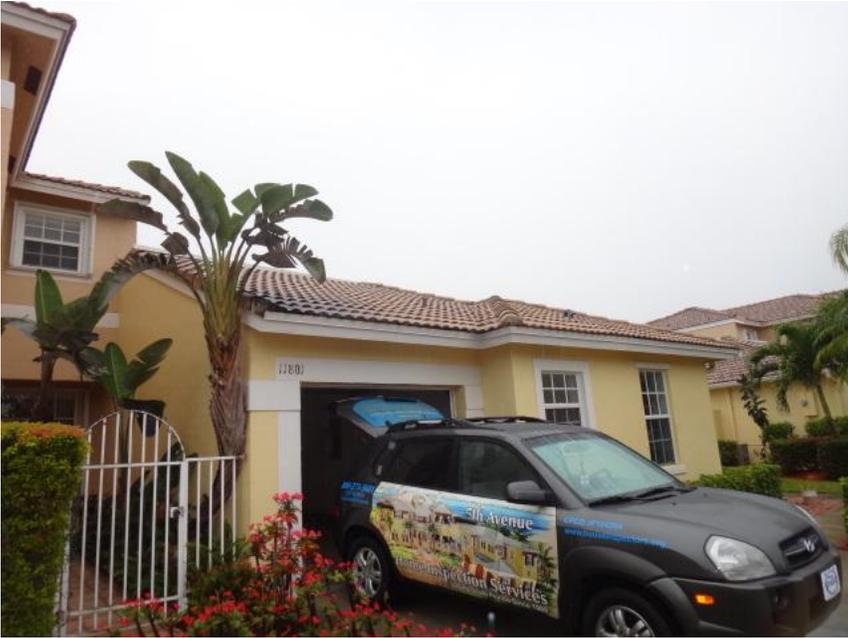
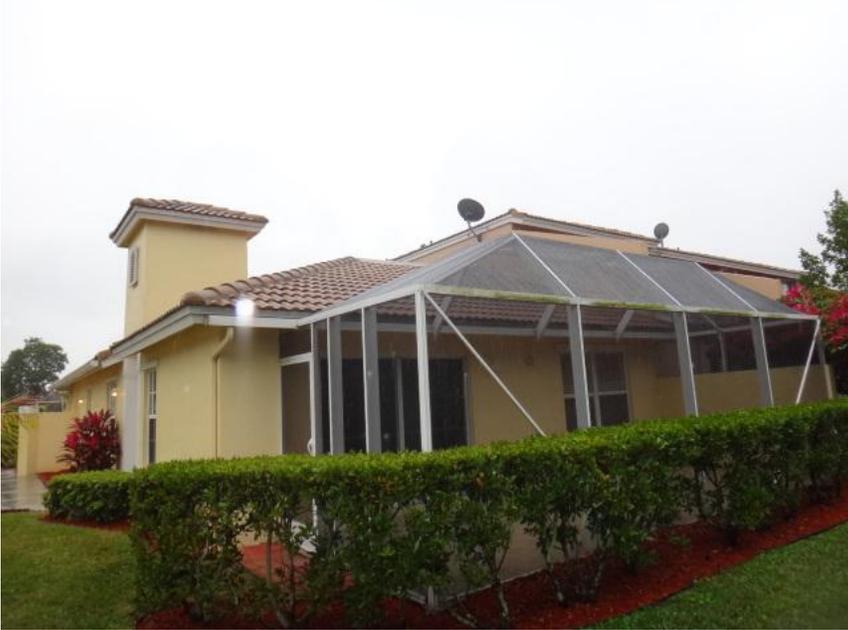
**5. Roof Geometry/Elevations**

Roof rated non-hip due to flat non-hip roof is greater than 10% of the total roof perimeter.
